**Flood Control Project Maintenance
Levee Inspections****2009 Channel Summary Report****Overall Unit and Item Ratings****Fairfield Suisun Sewer District**

Flood Control Project Maintenance**Unit Cover Sheet****2009 Channel Inspection Results****Fairfield Suisun Sewer District**

Channel
Laurel Creek

Fairfield Suisun Sewer District

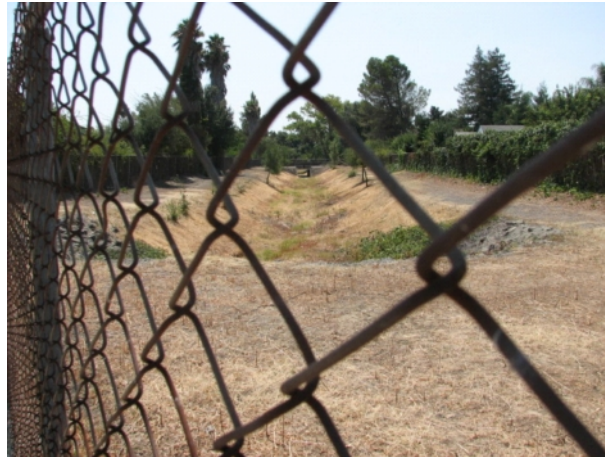
Levee Mile Report Line	6
Start Levee Mile	0.00
End Levee Mile	0.00
Location	
Category	Channels
Item	Vegetation & Obstructions
Maintenance has been done at Astoria Dr. 8-18-09	
johngw_20090819_62.jpg

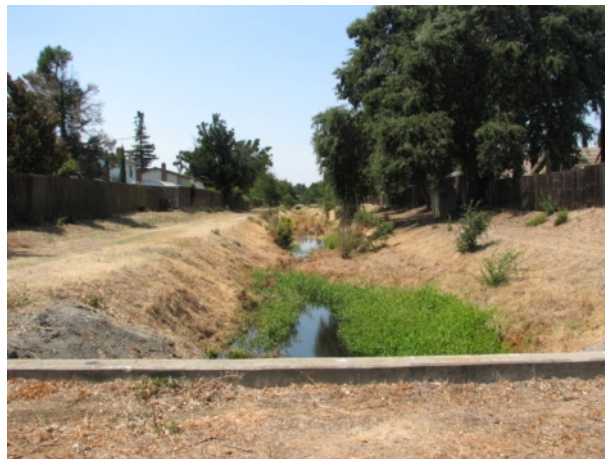
Levee Mile Report Line	6
Start Levee Mile	0.00
End Levee Mile	0.00
Location	
Category	Channels
Item	Vegetation & Obstructions
maintenance has been done at the start of channel off Oliver Rd. 8-18-09	
johngw_20090819_63.jpg

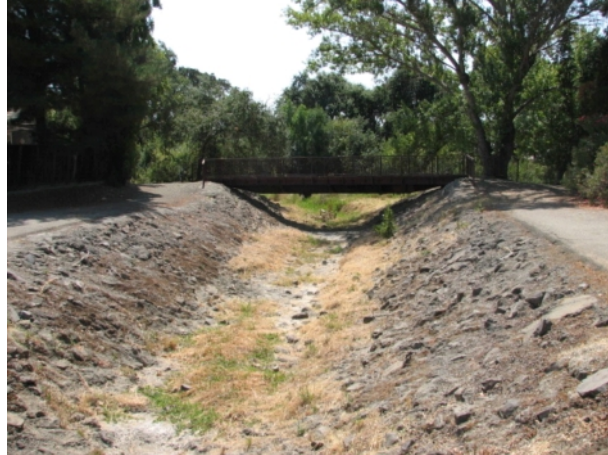
Levee Mile Report Line	16
Start Levee Mile	0.00
End Levee Mile	0.00
Location	
Category	Channels
Item	Vegetation & Obstructions
Maintenance has been done on Springview Dr. crossing 8-18-09	
johngw_20090819_61.jpg

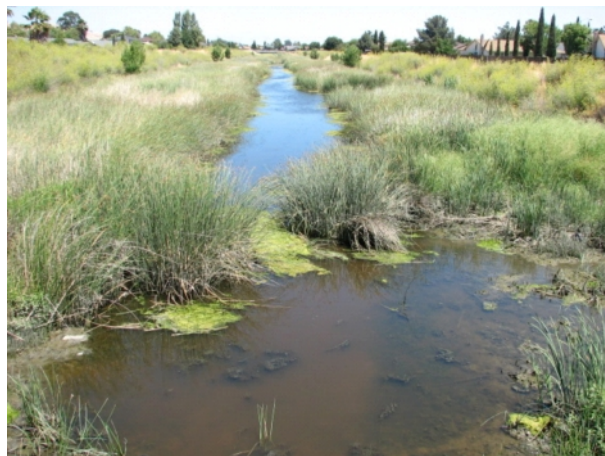
Levee Mile Report Line	31
Start Levee Mile	0.00
End Levee Mile	0.00
Location	
Category	Channels
Item	Vegetation & Obstructions
Upstream view from Hwy. 12 no access on downstream side 38.24361 -122.01057	
john_gw_20090723_35.jpg

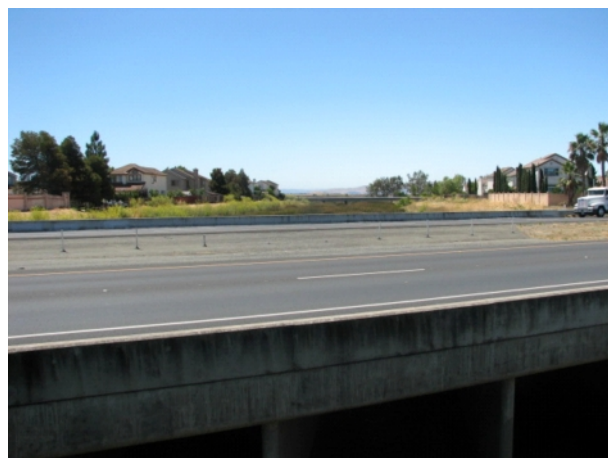
Levee Mile Report Line	36
Start Levee Mile	0.00
End Levee Mile	0.00
Location	
Category	Channels
Item	Vegetation & Obstructions
Looking downstream towards Anderson Dr. no access on downstream side 38.24361 -121.01057	
john_gw_20090723_38.jpg
